Experiment with SPS Radon Block – lubrication membrane.

Case no.:
2018-0256-10

Given:
June 13, 2019

Radon measurement and evaluation of the effect of lubrication membrane. The radon measurements were carried out with closed trace film dosimeters, which were set up and taken down by DMR A/S.

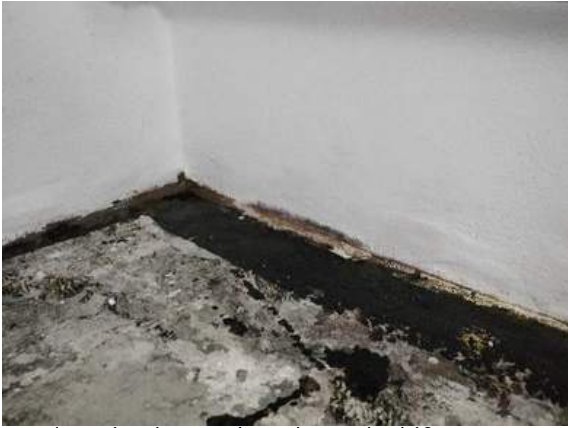
#1 Floor is cleaned and sanded if necessary before edges are sealed with a brush.

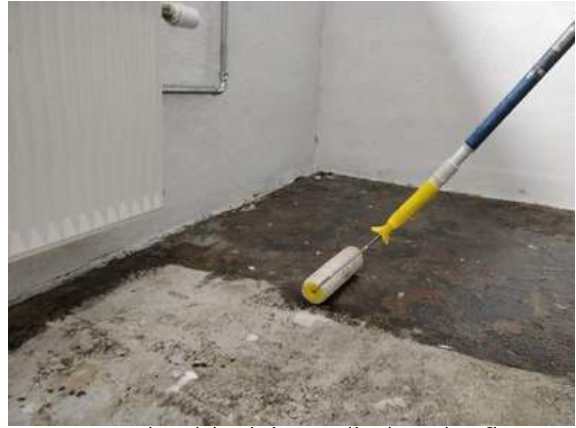
#2 SPS Radon block is applied to the floor surfaces with a roller.

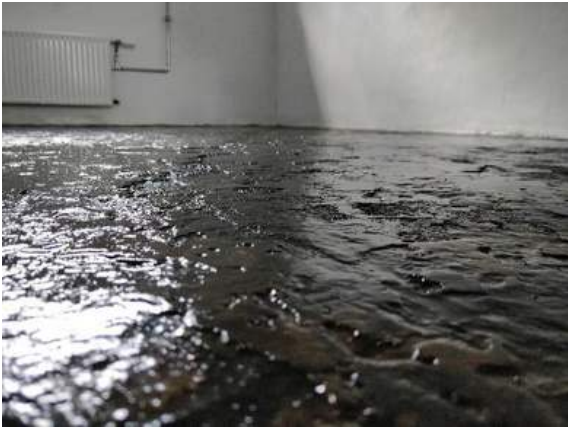
#3 After approx. 24 hours, the membrane is cured and the floor can be further treated.

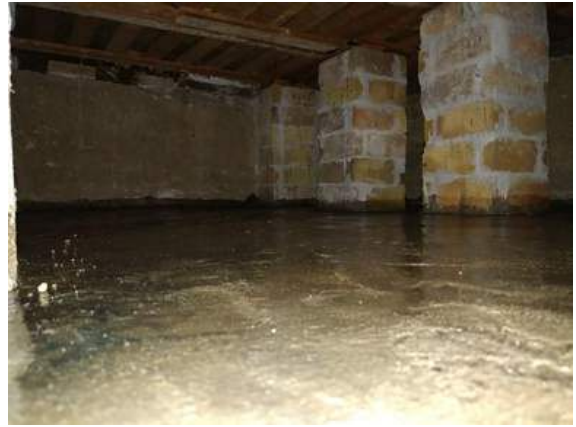
#4 Terrain tires i crawl space able to be treated accordingly.

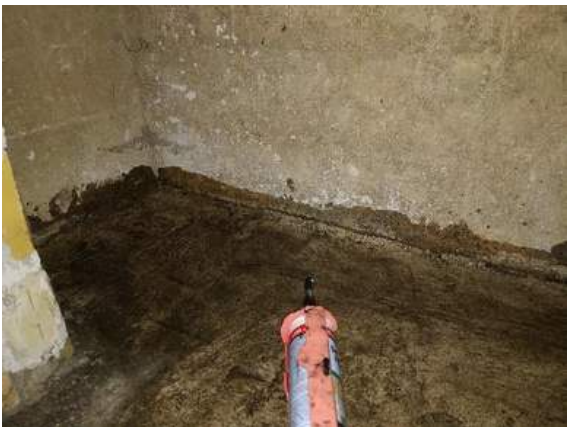
#5 Crawl space - larger cracks are sealed with suitable sealant.

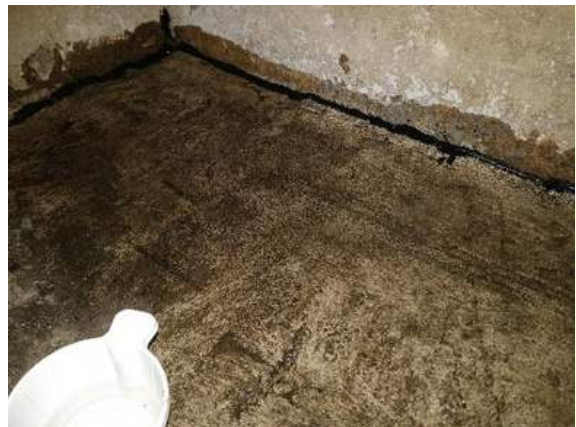
#6 Crawl space - larger cracks are sealed with suitable sealant.

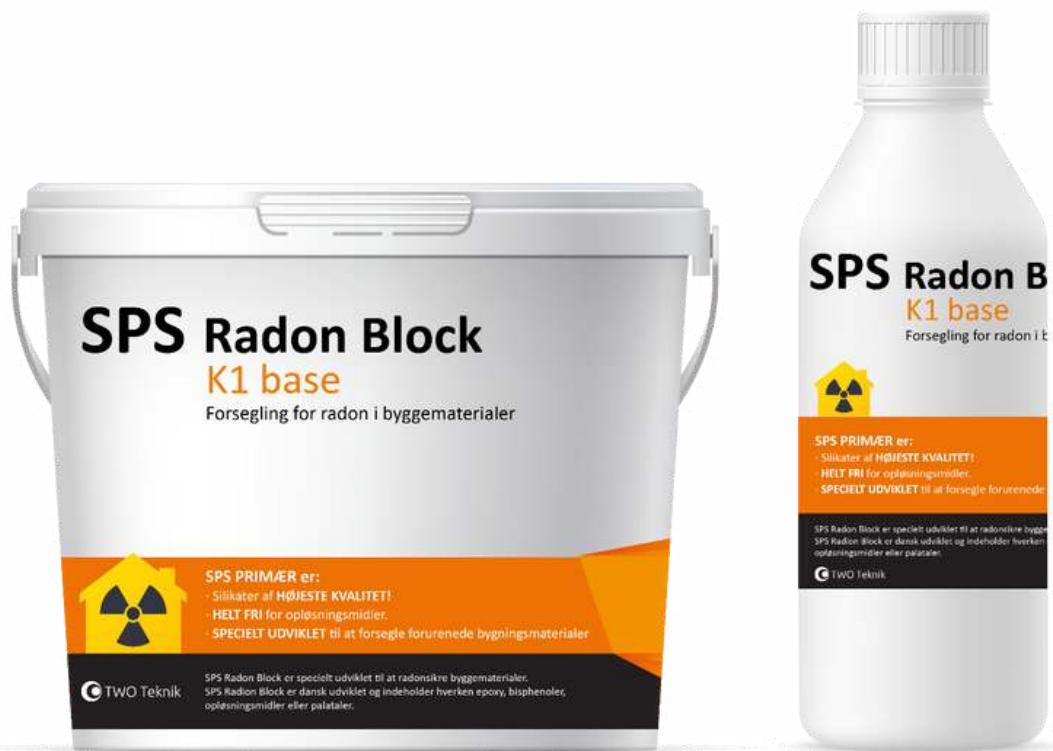
Other areas (rooms 1 and 2) are treated with lubrication membrane - SPS Radon Block, and the work was carried out by Tim Warner from TWO Teknik - see floor plan and photos.

Floor plans Shaded areas are treated with lubrication membrane - SPS Radon Block
